# West Howard Avenue

Urban Design Study
Kensington, Maryland
Montgomery County
Department of Housing and
Community Affairs

October 2009

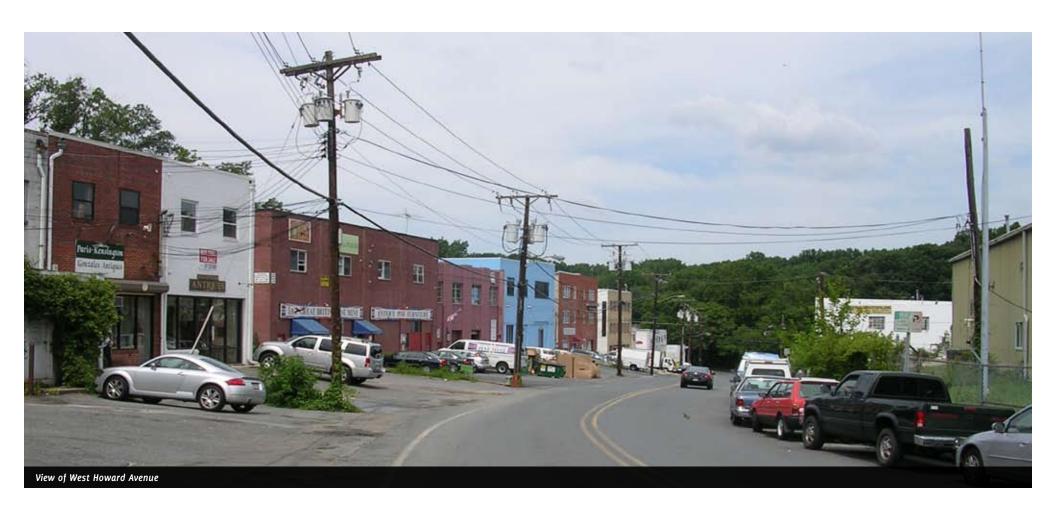
# 1. View of West Howard near Knowles Avenue 2. View of West Howard Looking West 3. View of West Howard looking towards Warfield Street

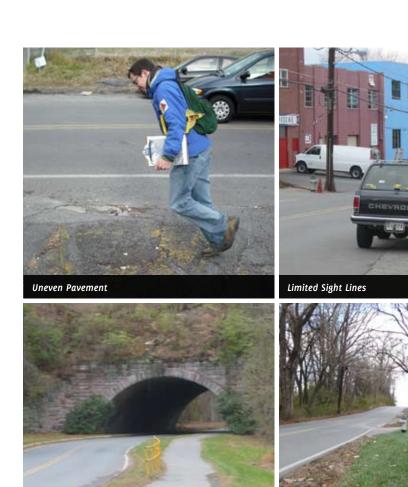
Hiker/Biker Trail Along Beach Drive In Rock Creek Park

Informal Path Along West Howard Near Warfield Street

Informal paths can be found throughout the study area, indicating where people desire to walk. Many of these paths are located between the study area and adjacent neighborhoods. Examples of these paths can be found along the southern shoulder of West Howard between Sparrows Antiques and Warfield Street and between the library site and the rear service area of study site. Just beyond the study area, streets accommodate pedestrian movement. For example, Knowles Avenue and West Howard Avenue, east of Summit Avenue, have sidewalks with clearly marked pedestrian crosswalks, while Beach Drive has a hiker/biker path.

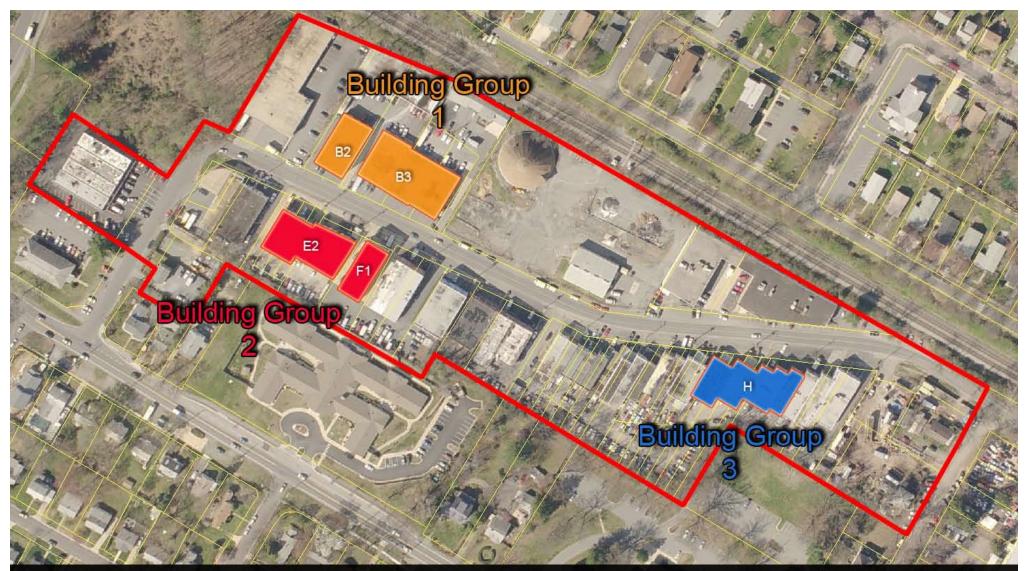
Key Plan of Typical Facade Studies

The buildings within the study area were primarily built from the 1950s through the 1970s and are a simple reflection of an industrial style of architecture. Typically, they are unadorned and principally utilitarian. Building heights vary, but are generally two stories. Access is generally from both the front and back of the structures. Grade conditions allow some buildings to be two stories where fronting West Howard Avenue and only one story at the rear of the buildings. The steep topography creates accessibility constraints for those who are physically disabled. While most businesses are entered at grade level, some are elevated and are only accessible by stairs.

Building exterior walls are primarily comprised of masonry in the form of brick or concrete block. A majority of the buildings along the west end of the study area have relatively flat facades and have similar setbacks from West Howard Avenue. The building facades along the east end tend to be more pronounced and step back from one another in a regular pattern. Many of the facades along Howard Avenue have been painted, or parged and then painted. There is evidence of cosmetic deterioration and minor structural compromise in some instances. These instances are

usually found around loading dock openings which are prone to damage from delivery trucks or at the base of buildings where moisture penetration is evident. However, there does not appear to be any major structural damage within the exterior masonry walls.

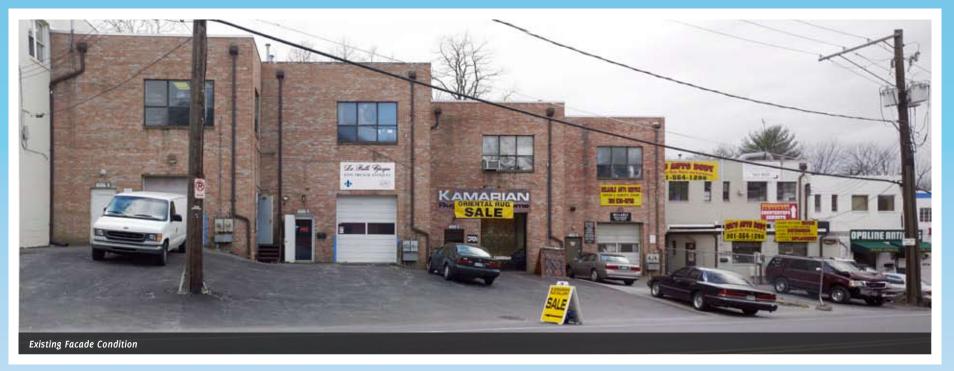
### | BUILDING GROUP 3 |

### ARCHITECTURE STYLE

· circa1959 Industrial

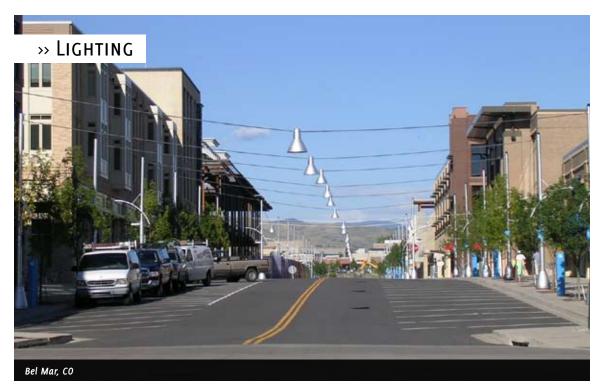
GOAL» Develop a site lighting strategy that unifies and enhances the industrial and contemporary character of West Howard Avenue and provides appropriate illumination for the safety of all users.

- 1. Introduce a common industrial language among street lighting fixtures to unify West Howard Avenue and service drives. Preference should be given to full cut off luminaries, which do project light upwards and energy-efficient street light fixtures.
- **2.** Provide appropriate illumination for vehicles and pedestrians. Introduce pedestrian scale lighting to better illuminate pedestrian movement along West Howard Avenue and between buildings and parking areas.
- **3.** Locate lighting fixtures to reinforce public spaces, such as along the storefronts, or overhanging the street and service lanes.
- **4.** Locate accent lighting to create interest and visual focus on prominent focal points, such as building signage.

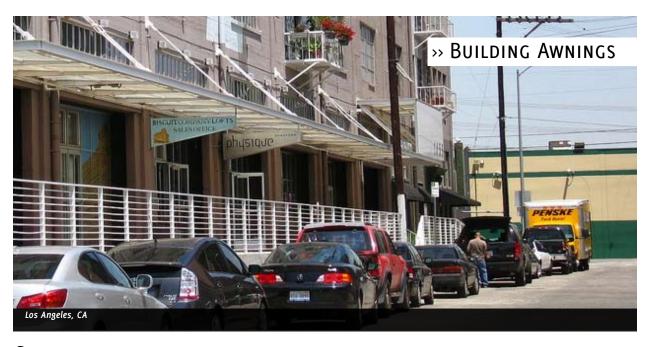
GOAL» Install awnings that reinforce the industrial character of West Howard Avenue, provide relief and scale to the building facades, accentuate and protect building entries, and provide solar shading.

- 1. Encourage the installation of a variety of awnings throughout the study area to celebrate individual businesses and buildings.
- 2. Install awnings that best support the industrial character
  - a. Industrial awnings- constructed of raw materials, such as metal, and demonstrating how materials are assembled.
  - b. Contemporary awnings- minimalist and simple forms to correspond to the simple forms of the existing buildings
- 3. Locate awnings at building entries to define business storefronts and their counterpart pedestrian areas in front of entries.

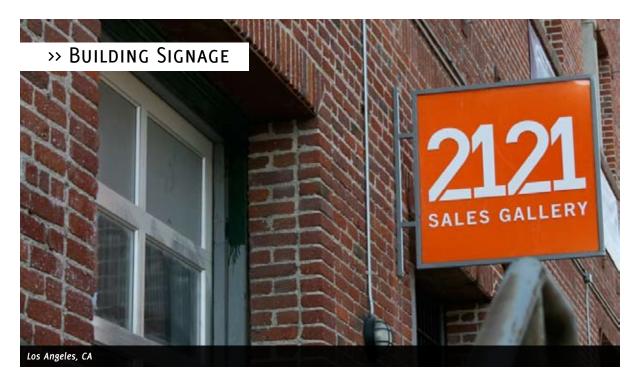
- 1. Display business names and logos using durable signage materials and methods.
- **2.** Encourage a variety of sign types and sizes to help reinforce the eclectic nature of this business community. Example of signs include but are not limited to the following: superscript lettering painted on the building facades, neon backlit metal lettering and wall-hung sign boards.
- **3.** Develop a standard system to prominently display building address numbers. This layer of signage provides order among the variety of businesses and helps people locate their destination.

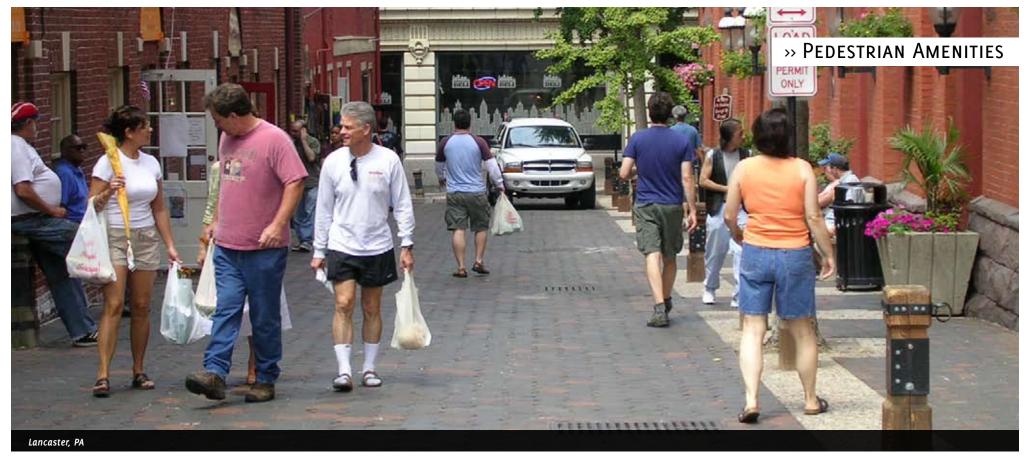
GOAL» Develop a safe and comfortable pedestrian streetscape and network.

- 1. Use curbs, bollards and other landscape features to create buffers between pedestrians and automobiles. Where a clear separation between pedestrians and vehicles is not possible, such as at crosswalks, introduce material changes and signage to bring awareness to motorists of pedestrians.
- 2. Strategically locate pedestrian amenities, such as benches and trash receptacles to provide some basic comforts for people.
- 3. Introduce landscape and streetscape elements that are finely scaled and detailed to attract interest to passer-bys.
- 4. Provide street trees where possible.

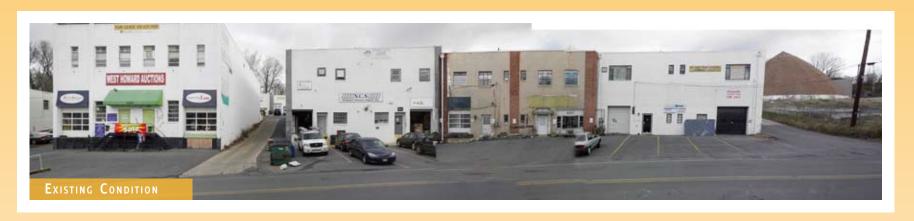
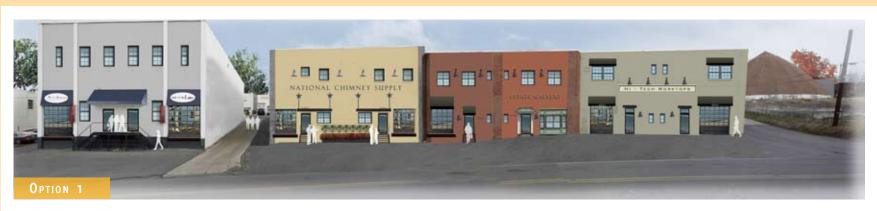
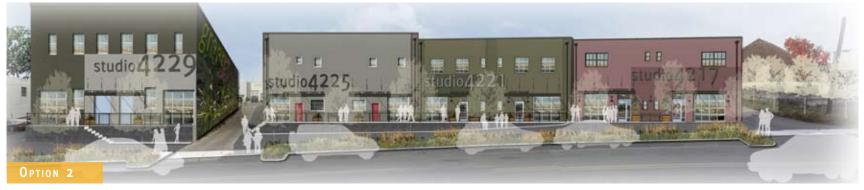
# » RECOMMENDATIONS APPLIED TO BUILDING GROUP 1

- 1. Superscript Address Signage- Bold and large lettering painted on the building's surface to provide clear indication of the building's location, and echo industrial era traditions.

The recommendations listed above are an outline of facade improvements that may be employed on other buildings in the West Howard Avenue study area.

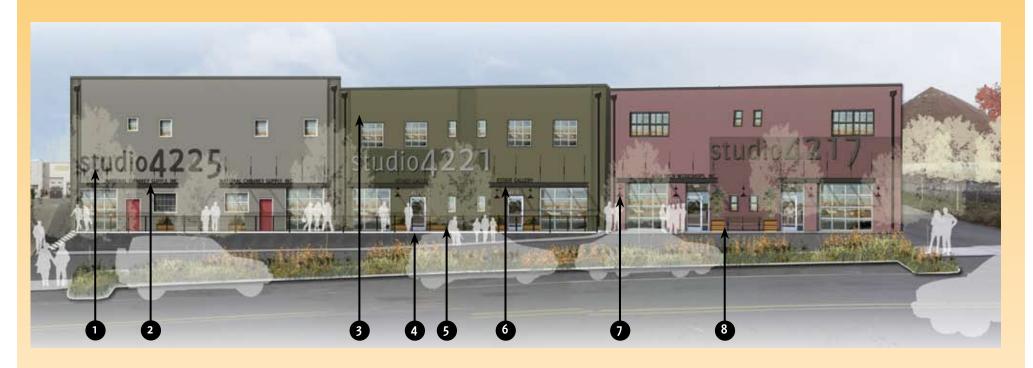
- **2.** Business Signage- Introduce smaller scale signs to address businesses.
- **3.** Paint Facades- Paint facades in soft earth tones. Breakup the buildings' mass by introducing a secondary color to define individual storefront.

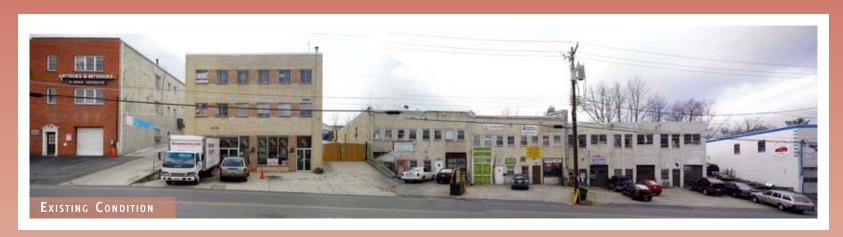
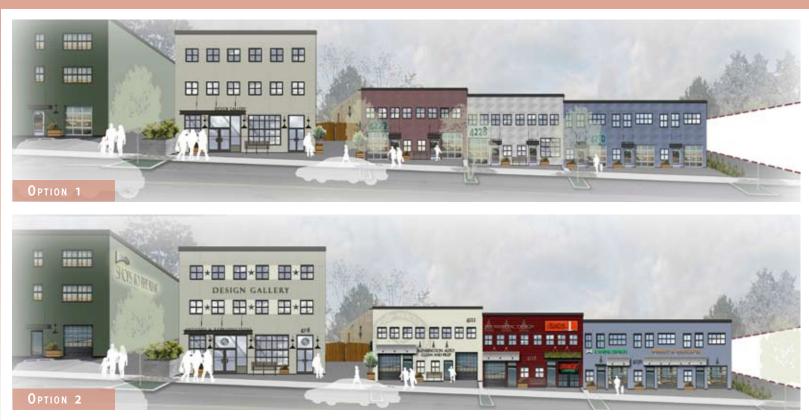
# » RECOMMENDATIONS APPLIED TO BUILDING GROUP 2

- 1. Painted Logos: Paint business logos onto facades.
- 2. Color: Paint facades using cool and bright colors.
- **3.** Accent Lighting: Enhance the visibility of business signage by using backlighting, neon lighting or direct lighting.
- **4.** Signage: Apply signage to the facade to bring order and break down the scale of buildings. Signs can range from simple metallic letters to durable (metal, or high-quality fabrics and plastics) sign boards with graphic imagery and text.
- **5.** Cornice Line: Apply a contrasting and darker color to the cap of the building, distinguishing the upper edge of the building from the sky.
- **6.** Canopies: Place canopies over store fronts and doors to reinforce frontage and add order to the facade.

The recommendations listed above are an outline of facade improvements that may be employed on other buildings in the West Howard Avenue study area.

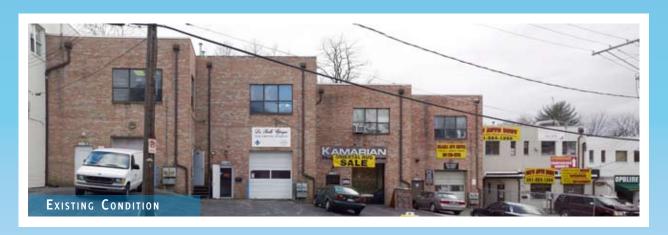
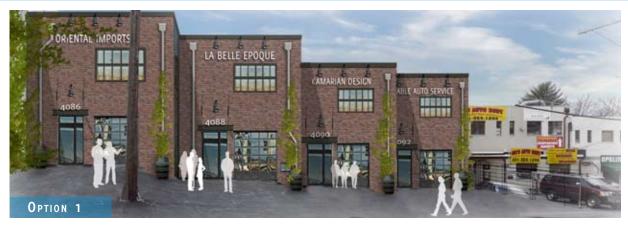
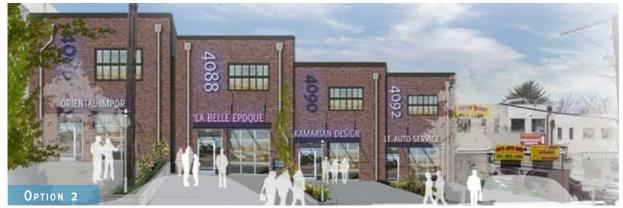
# >> RECOMMENDATIONS APPLIED TO BUILDING GROUP 3

- Signage: Apply superscript address numbers
  vertically on the building to contrast the horizontal
  nature of existing windows. Animate signs with vivid
  and bright colors and lighting to contrast the dark brick.
- **2.** Brick: Repair and clean brick to express its natural color. This is most applicable to structures whose brick is in good condition and have an interesting color.
- **3.** Canopy: Align canopy over storefront windows and entry doors, enhancing the human scale and unifying the ground floor businesses.
- **4.** Downspouts: Disconnect downspouts from direct runoff or underground pipes and allow downspouts to hydrate rain gardens or fill rain barrels. Emphasize these vertical elements by exposing their metallic

**5.** Garage Doors: Replace oqaque doors with glazed doors to enlarge business transparency to the street. Where possible, replace garage doors with a storefront glazing system to provide better insulation.

The recommendations listed above are an outline of facade improvements that may be employed on other buildings in the West Howard Avenue study area..

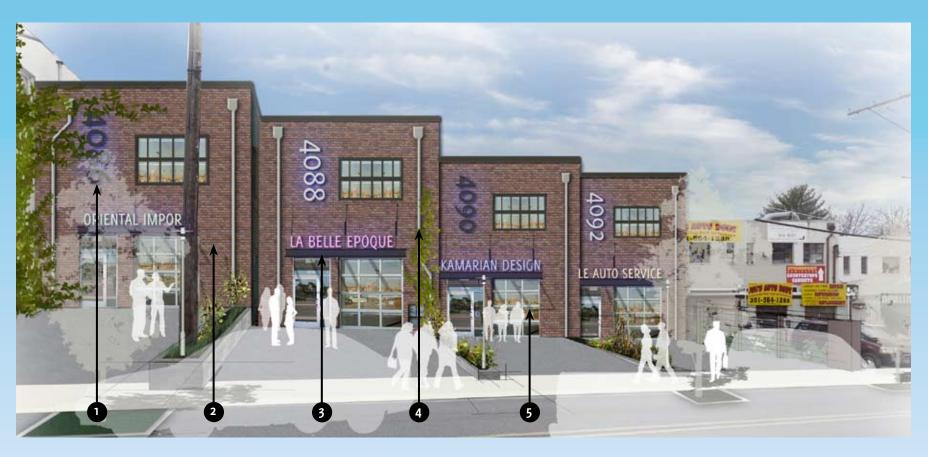
finishes or using a contrasting color.

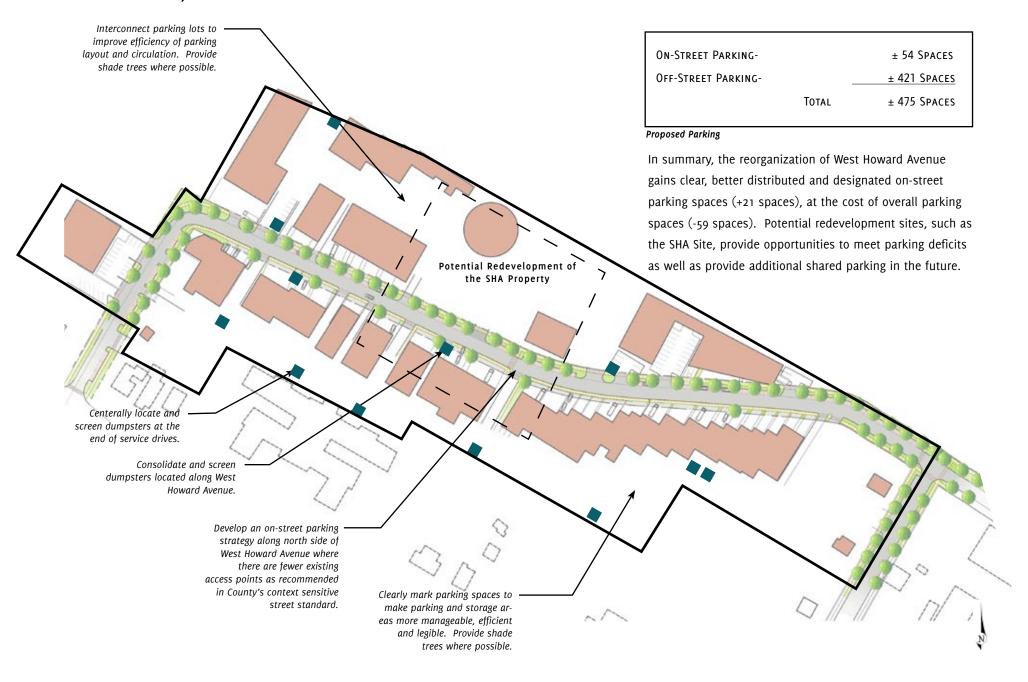
# >> CIRCULATION, SERVICE ACCESS & PARKING RECOMMENDATIONS

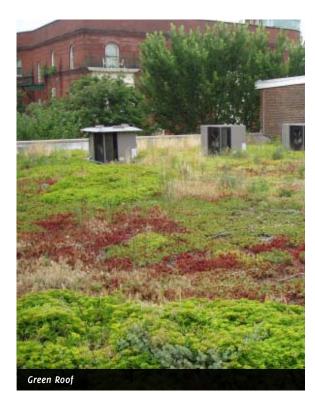
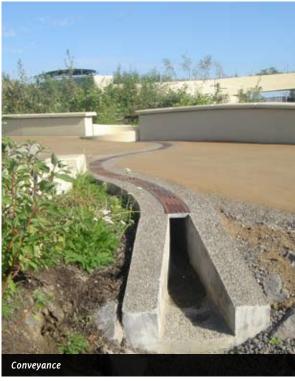
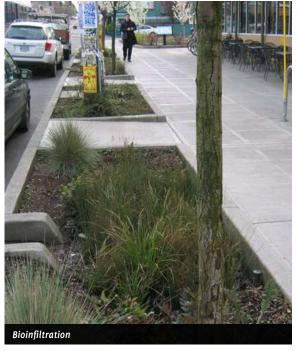
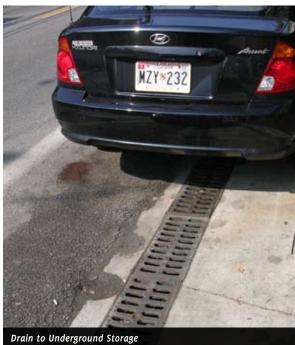
- 1. Reduce surface imperviousness by introducing planting areas along West Howard Avenue and integrating planter boxes where removing the hardscape is not feasible.
- **2.** Develop comprehensive stormwater management strategy within the street right-of-way with:.
  - · Sand Filter- locate beneath streets
  - Permeable Pavers- locate in areas of minimal impact, such as in areas for parking spaces
  - Biofiltration- locate along West Howard to serve both as a landscape and stormwater feature
  - · Oversized pipes- locate beneath streets
- **3.** Encourage off-site strategies to mitigate of stormwater runoff:
  - · Rain gardens
  - · Redirect downspouts to pervious areas
  - · Green roof treatments
